NATIONAL BUREAU OF STANDARDS REPORT

3325

REPORT ON
INSPECTION AND TESTS OF PLASTER
ALASKA NATIVE SERVICE HOSPITAL AND QUARTERS BUILDINGS

for the
BUREAU OF INDIAN AFFAIRS
U.S. DEPT. OF THE INTERIOR

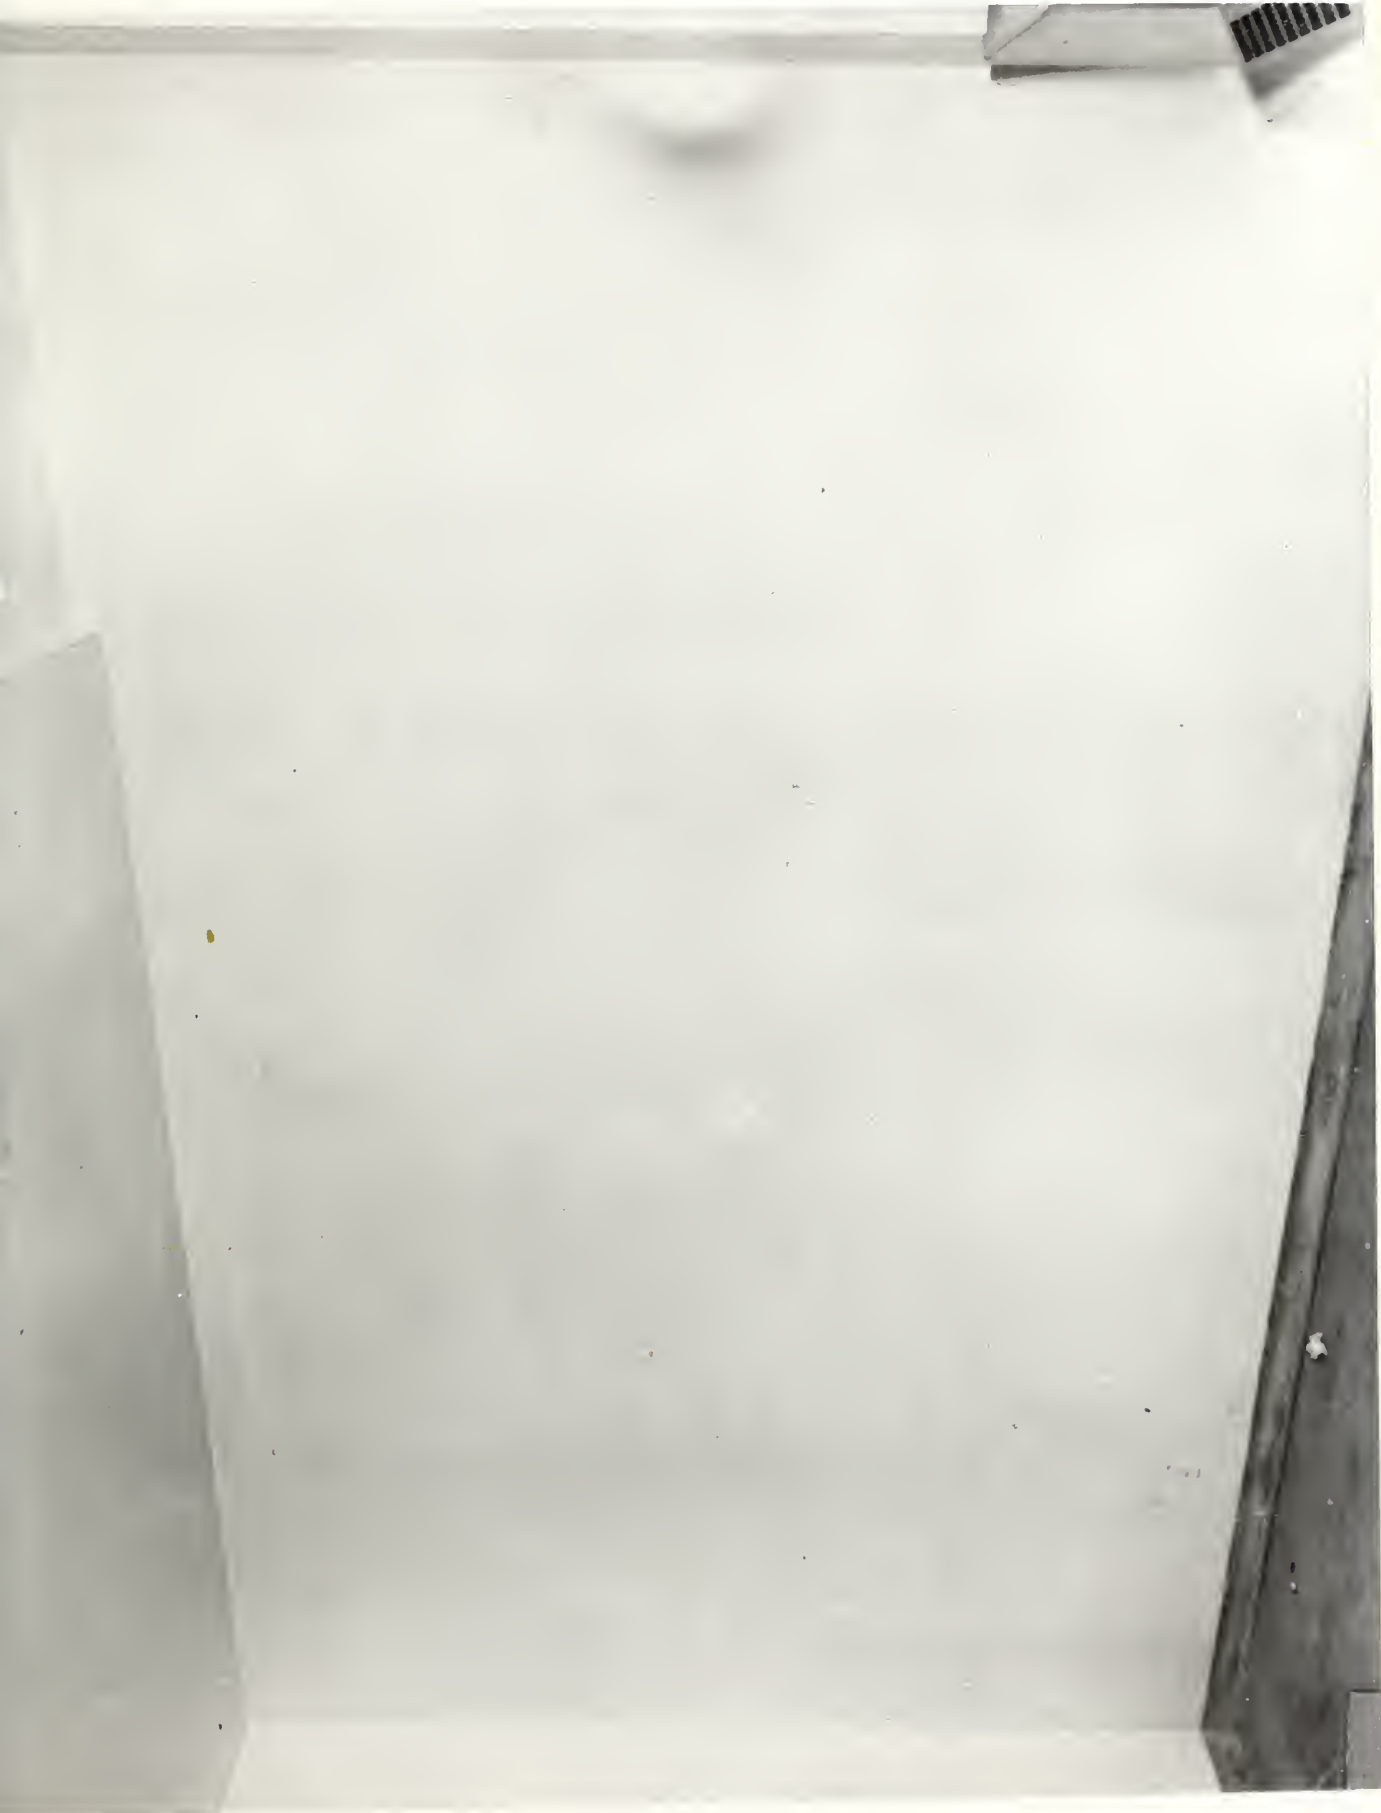
FIGURE 1. PROJECT 501-228. WALL SECTION OF ROOM N-125 (DINING ROOM). THE CRACK PATTERN IS TYPICAL OF STEEL-STUD WALLS AND HING CEILLINGS IN THE FIRST STORY. THE 9-BY 15-FT. WALL AREA SHOWN REQUIRED 86 LIN. FT. OF REPAIR.

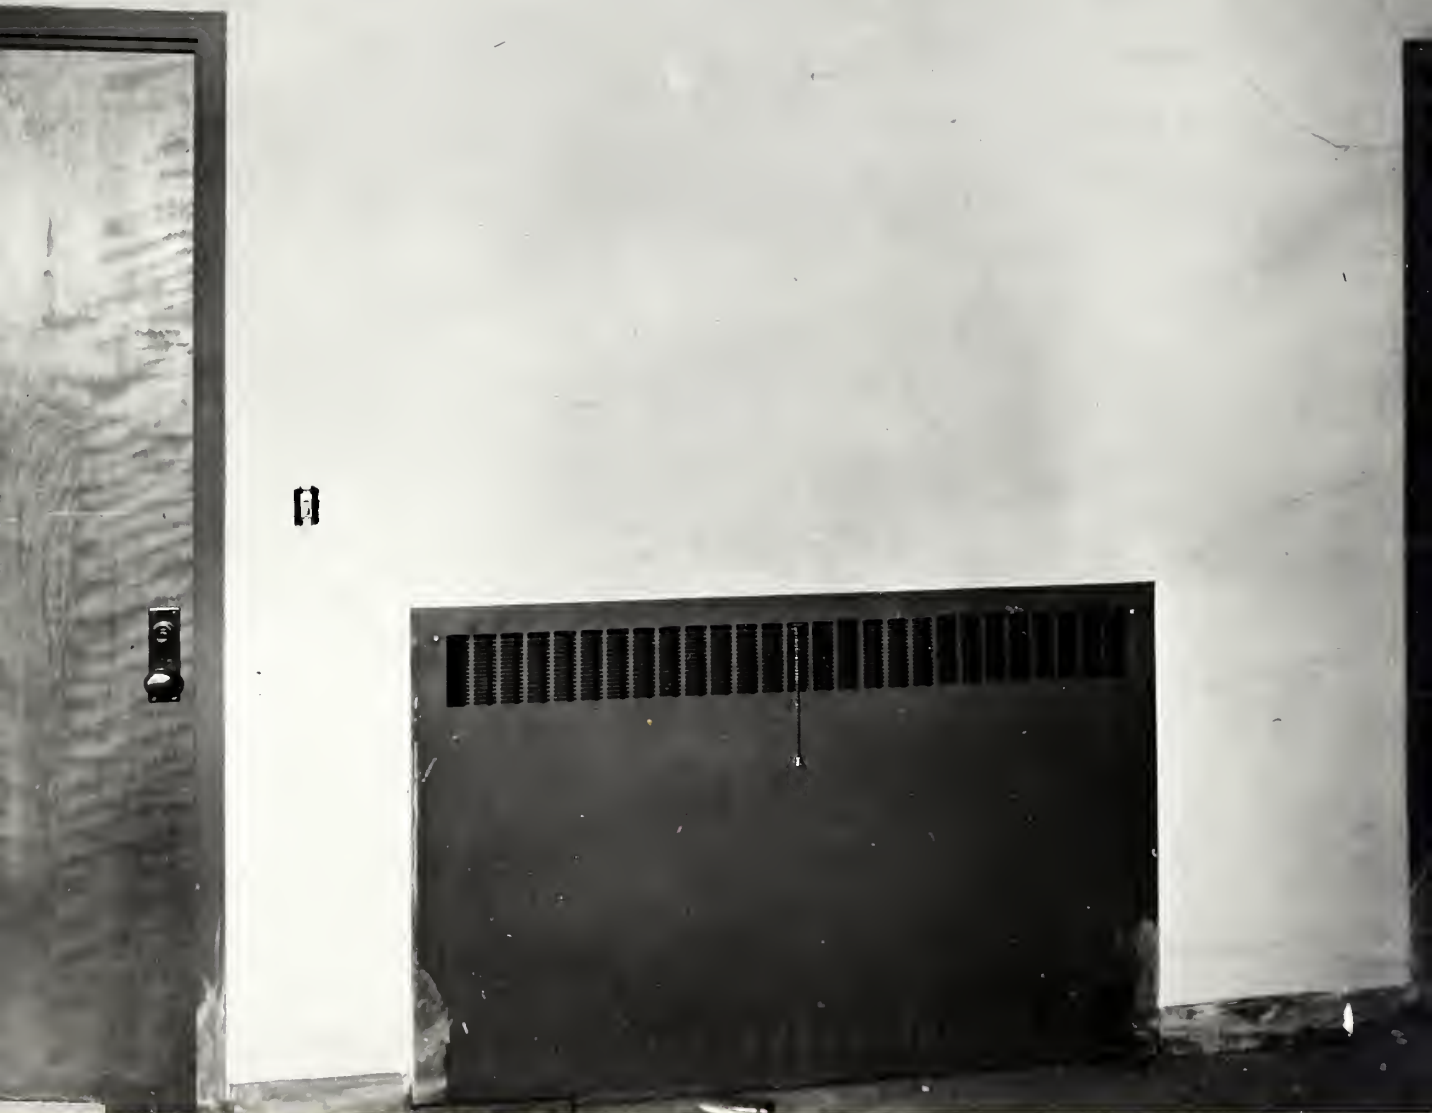
FIGURE 2. PROJECT 501-228. WALL OF ROOM W-149 (WAITING ROOM), A TYPICAL STEEL-STUD CONSTRUCTION, THE CRACK PATTERN OF WHICH WAS THE SAME AS IN OTHER AREAS. THE 11-BY 20-FT. AREA SHOWN REQUIRED 139 LIN. FT. OF REPAIR.

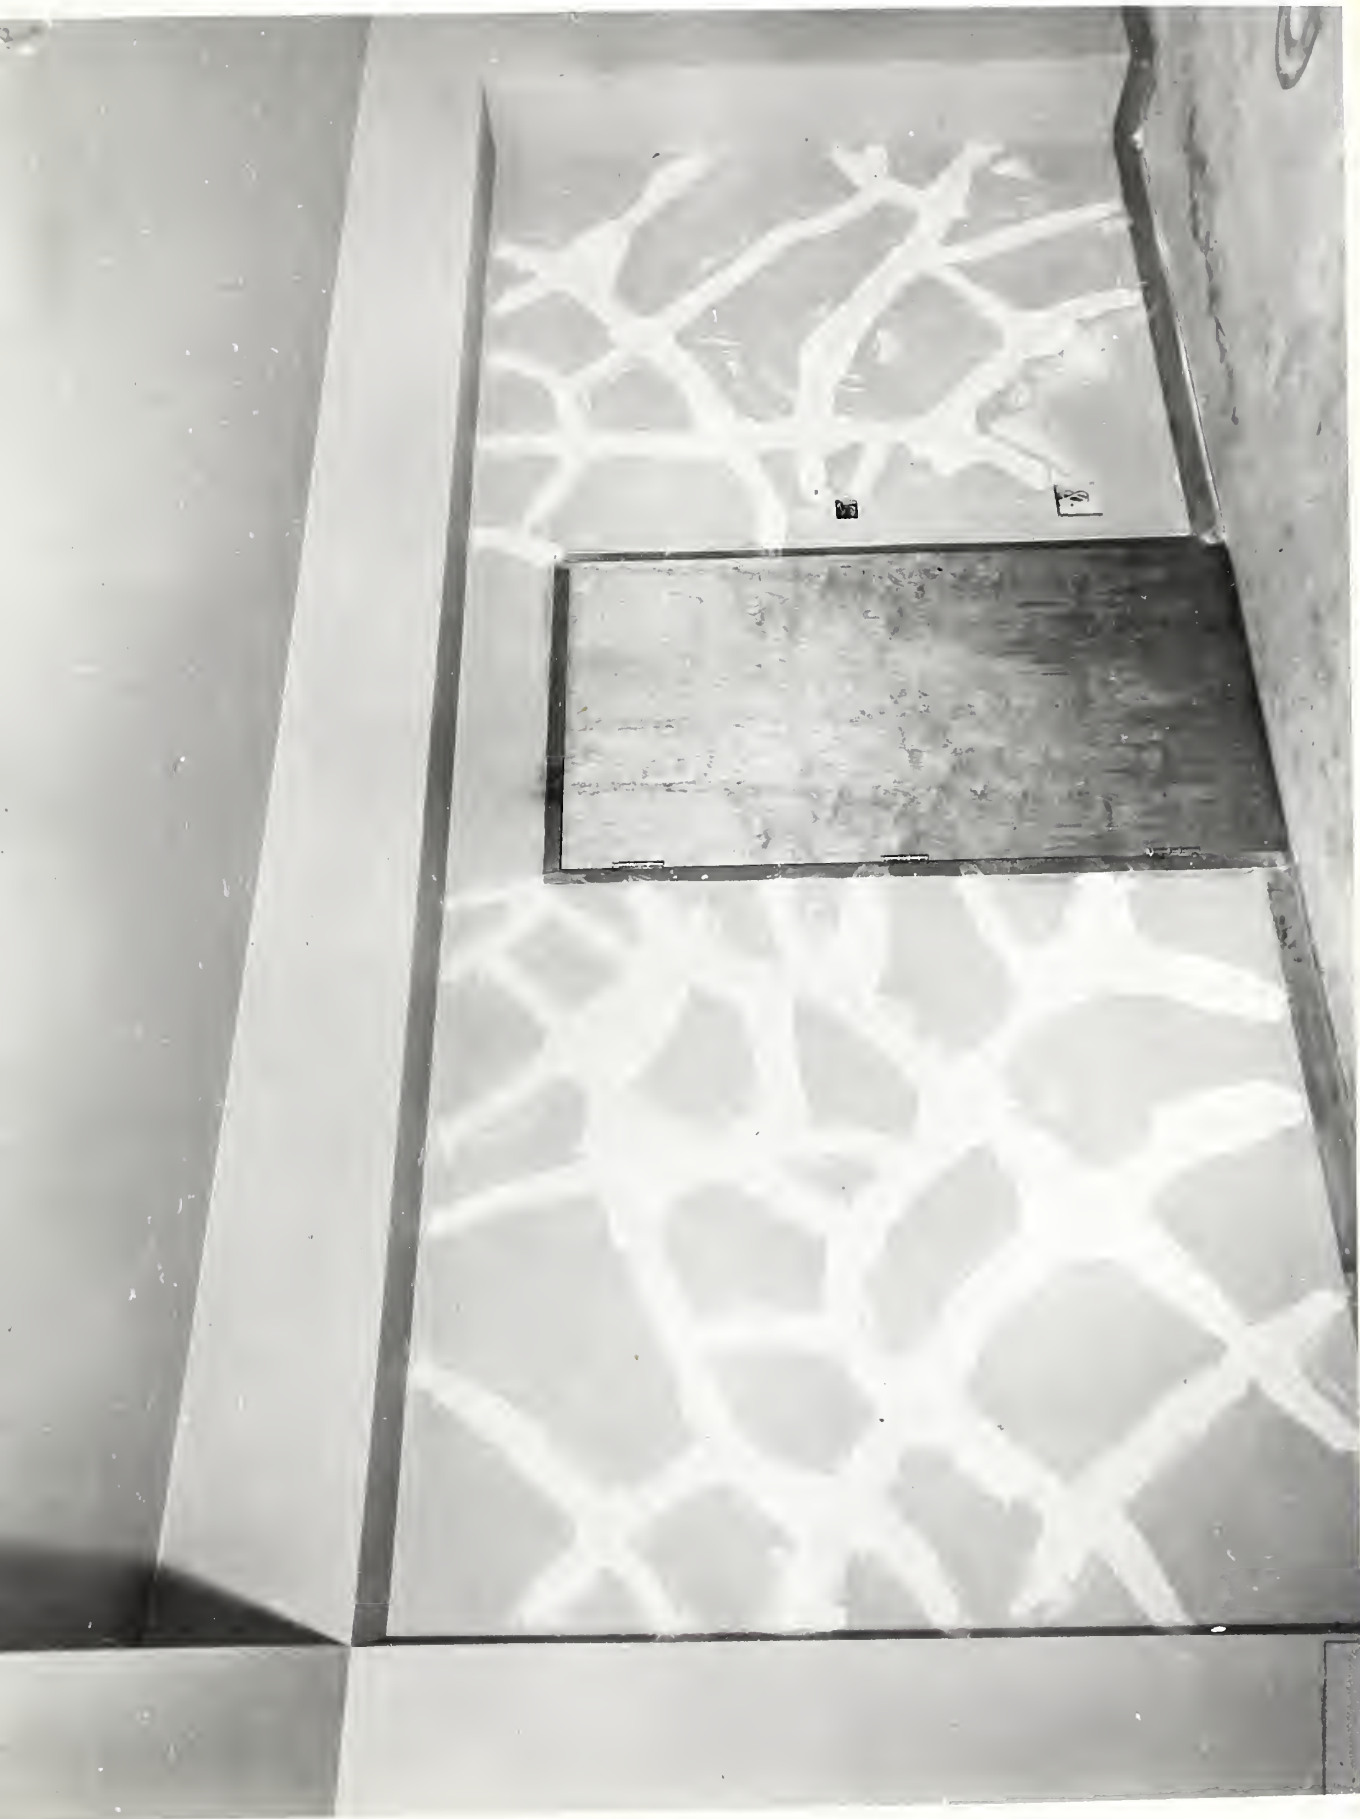
FIGURE 3. PROJECT 501-228. NORTH WALL OF ROOM E-202. CRACK PATTERN AND CONDITION TYPICAL OF ALL STEEL-STUD WALLS ON SECOND FLOOR. THIS WALL REQUIRED 90 LIN. FT. OF REPAIR FOR THE 8-BY 5-FT. SECTION SHOWN.

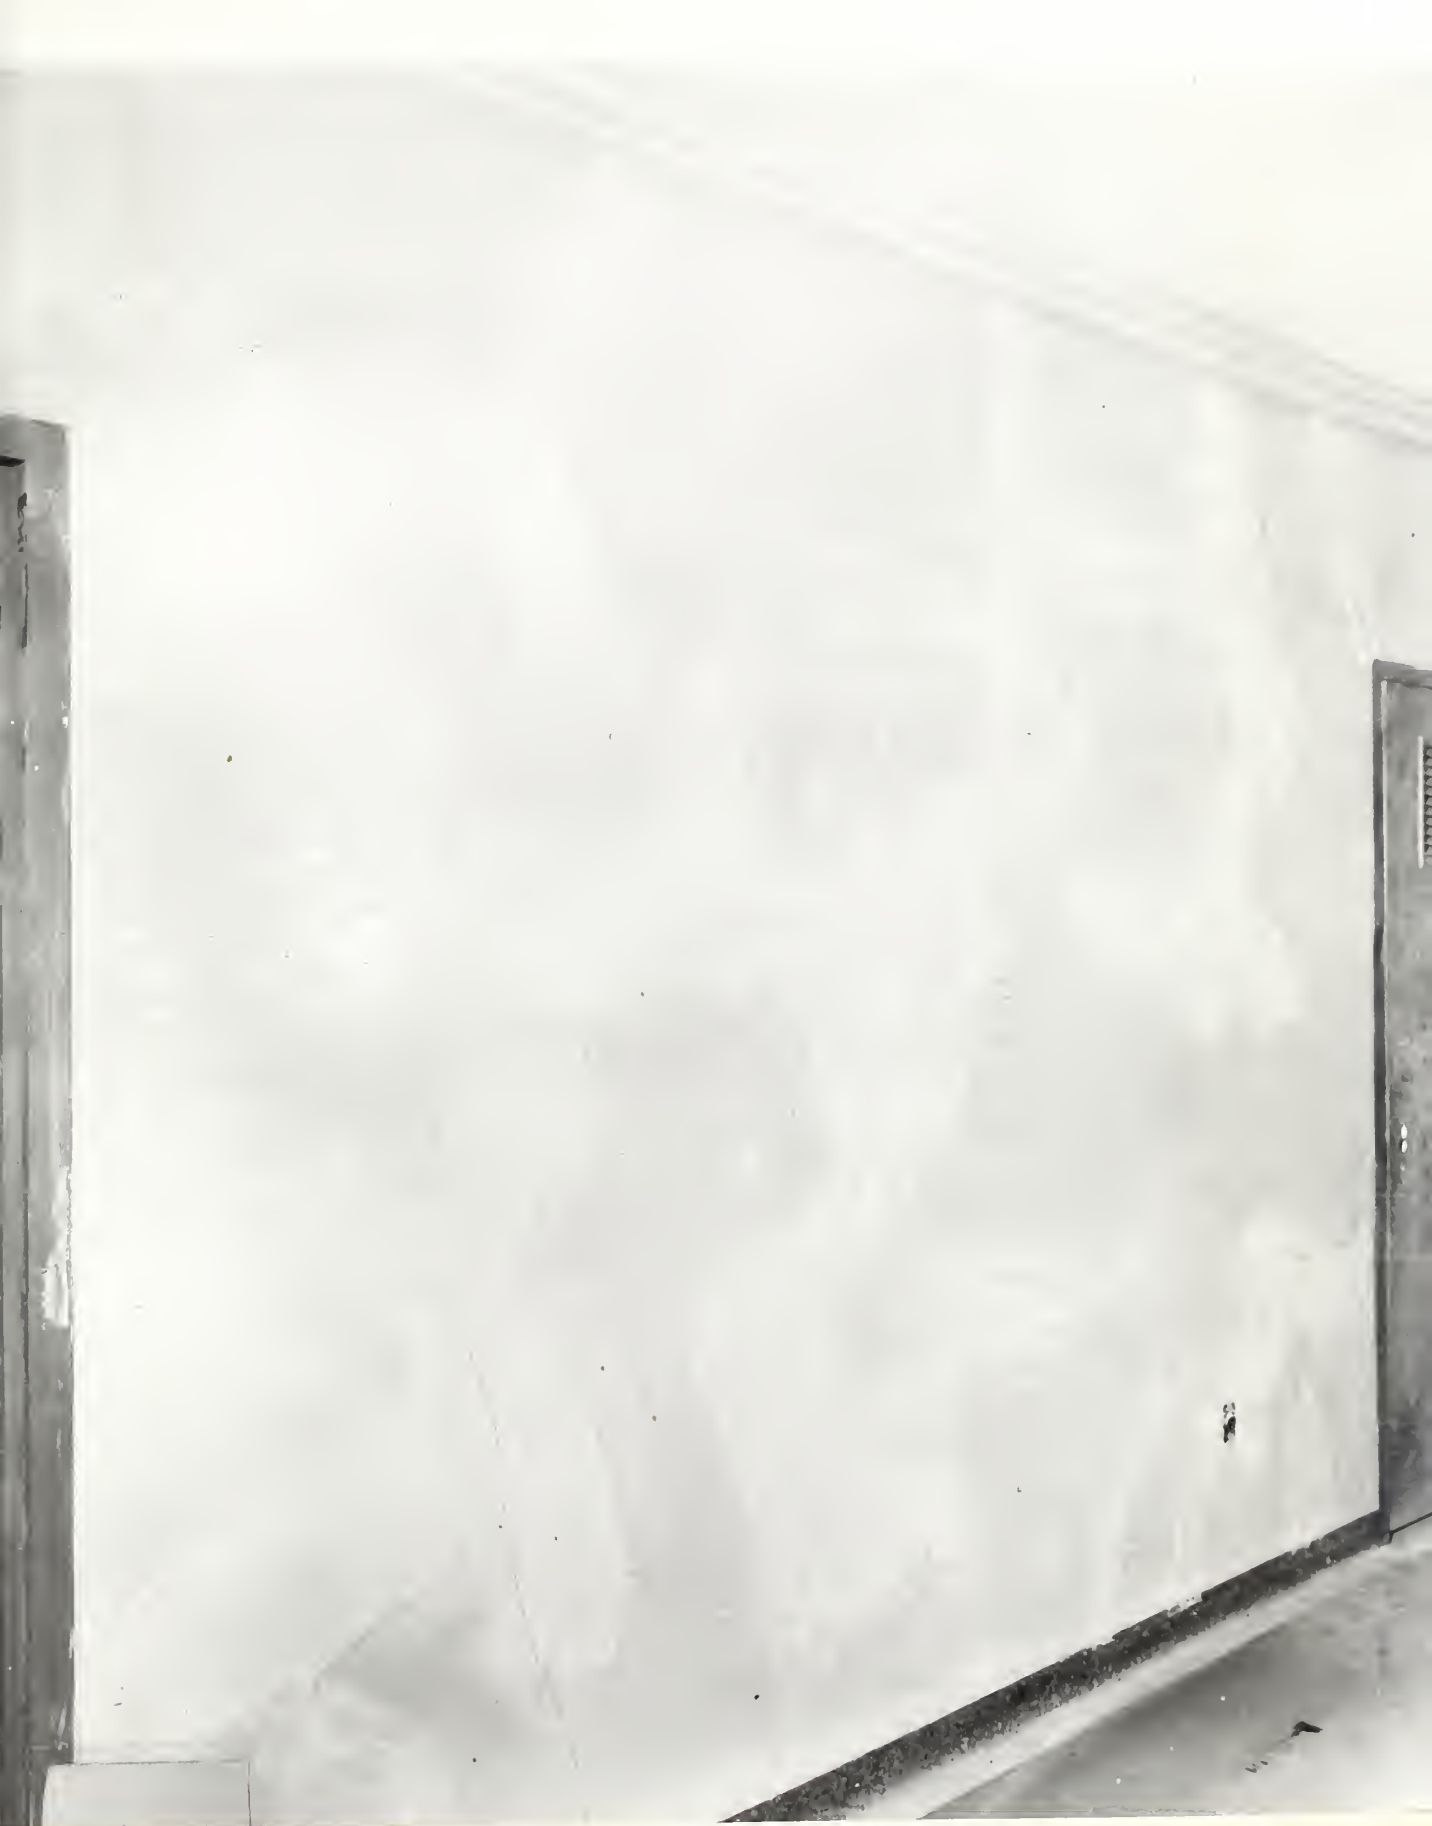
Figures 1 to 8, inclusive, show the typical pattern of cracking of the plaster in the hospital building. In some instances, the principal cracks were in long curves (Fig. 4), many reaching to the metal electrical outlet boxes, (Figs. 5, 6, and 7). It is likely that many of these cracks started at the outlet boxes.

FIGURE 4. PROJECT 501-228. CORRIDOR E-501; 99% OF CRACKS THROUGH TO LATH. THIS WALL REQUIRED 73 LIN. FT. OF REPAIR ON 9-BY 10-FT. AREA SHOWN.

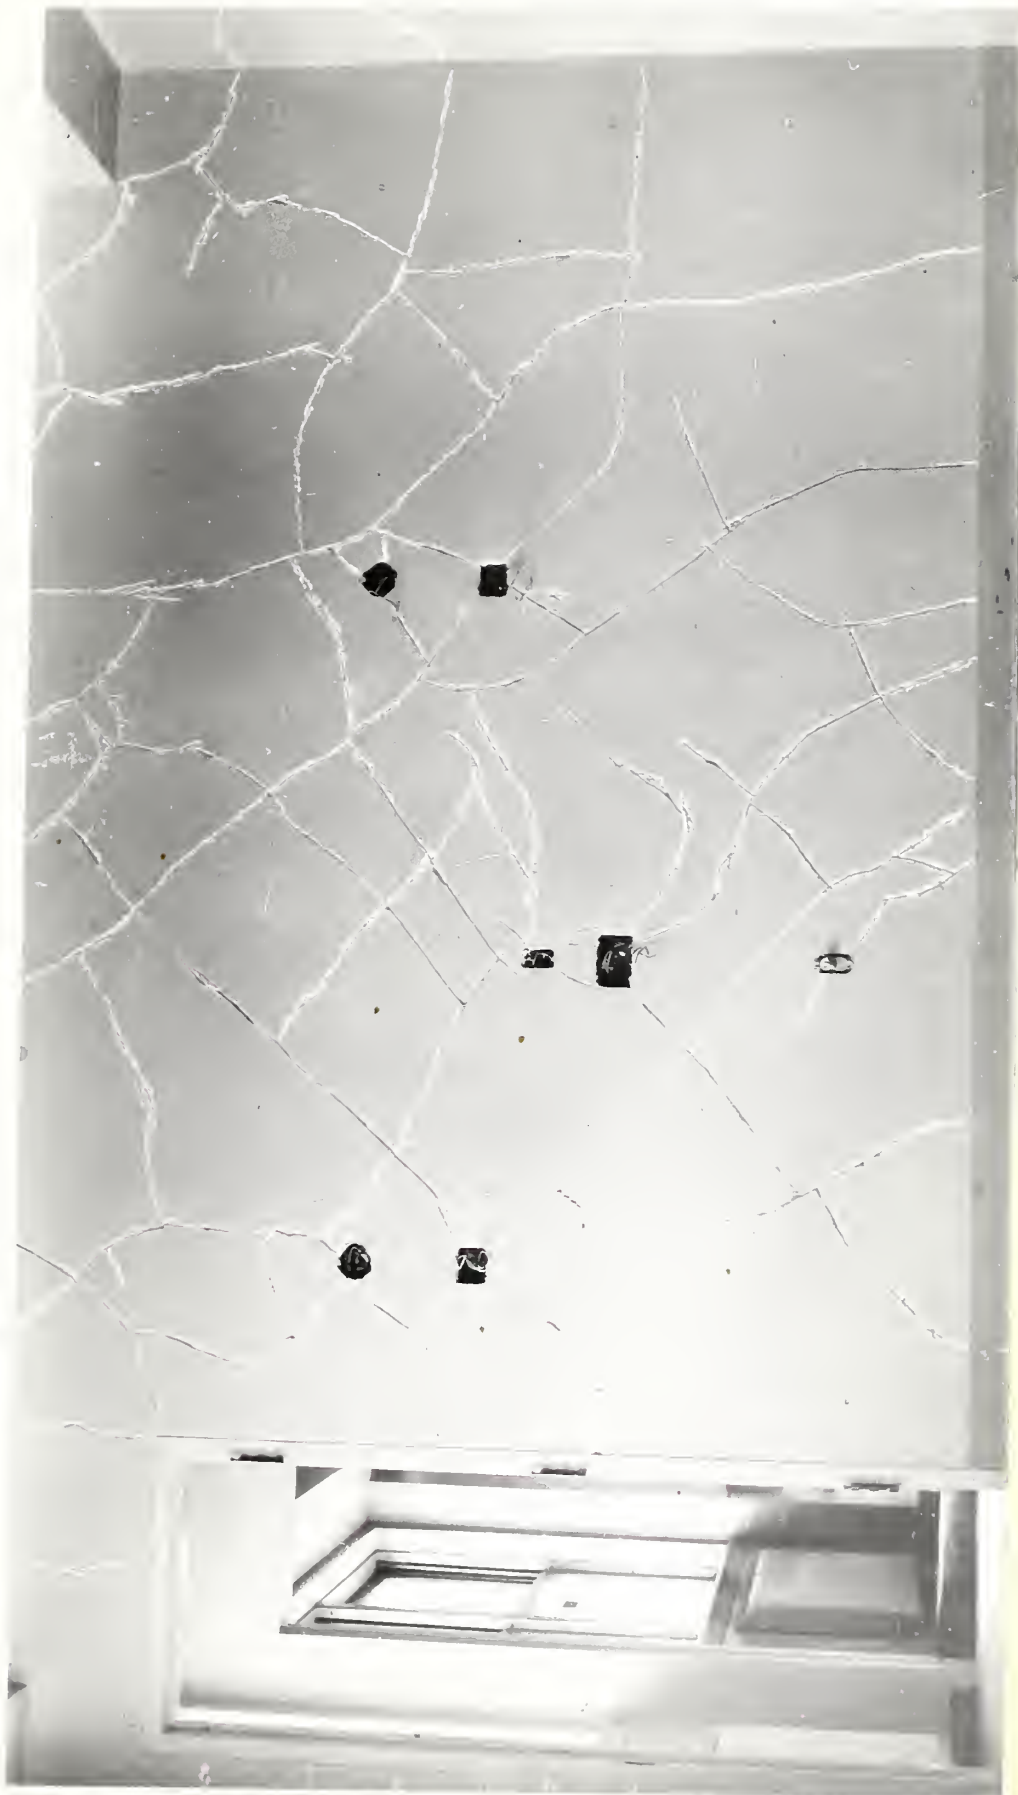
FIGURE 5. PROJECT 501-228. NORTH WALL OF ROOM N-518 (PRINTED REVERSED) SHOWING CRACKS GROOVED READY TO BE FILLED.

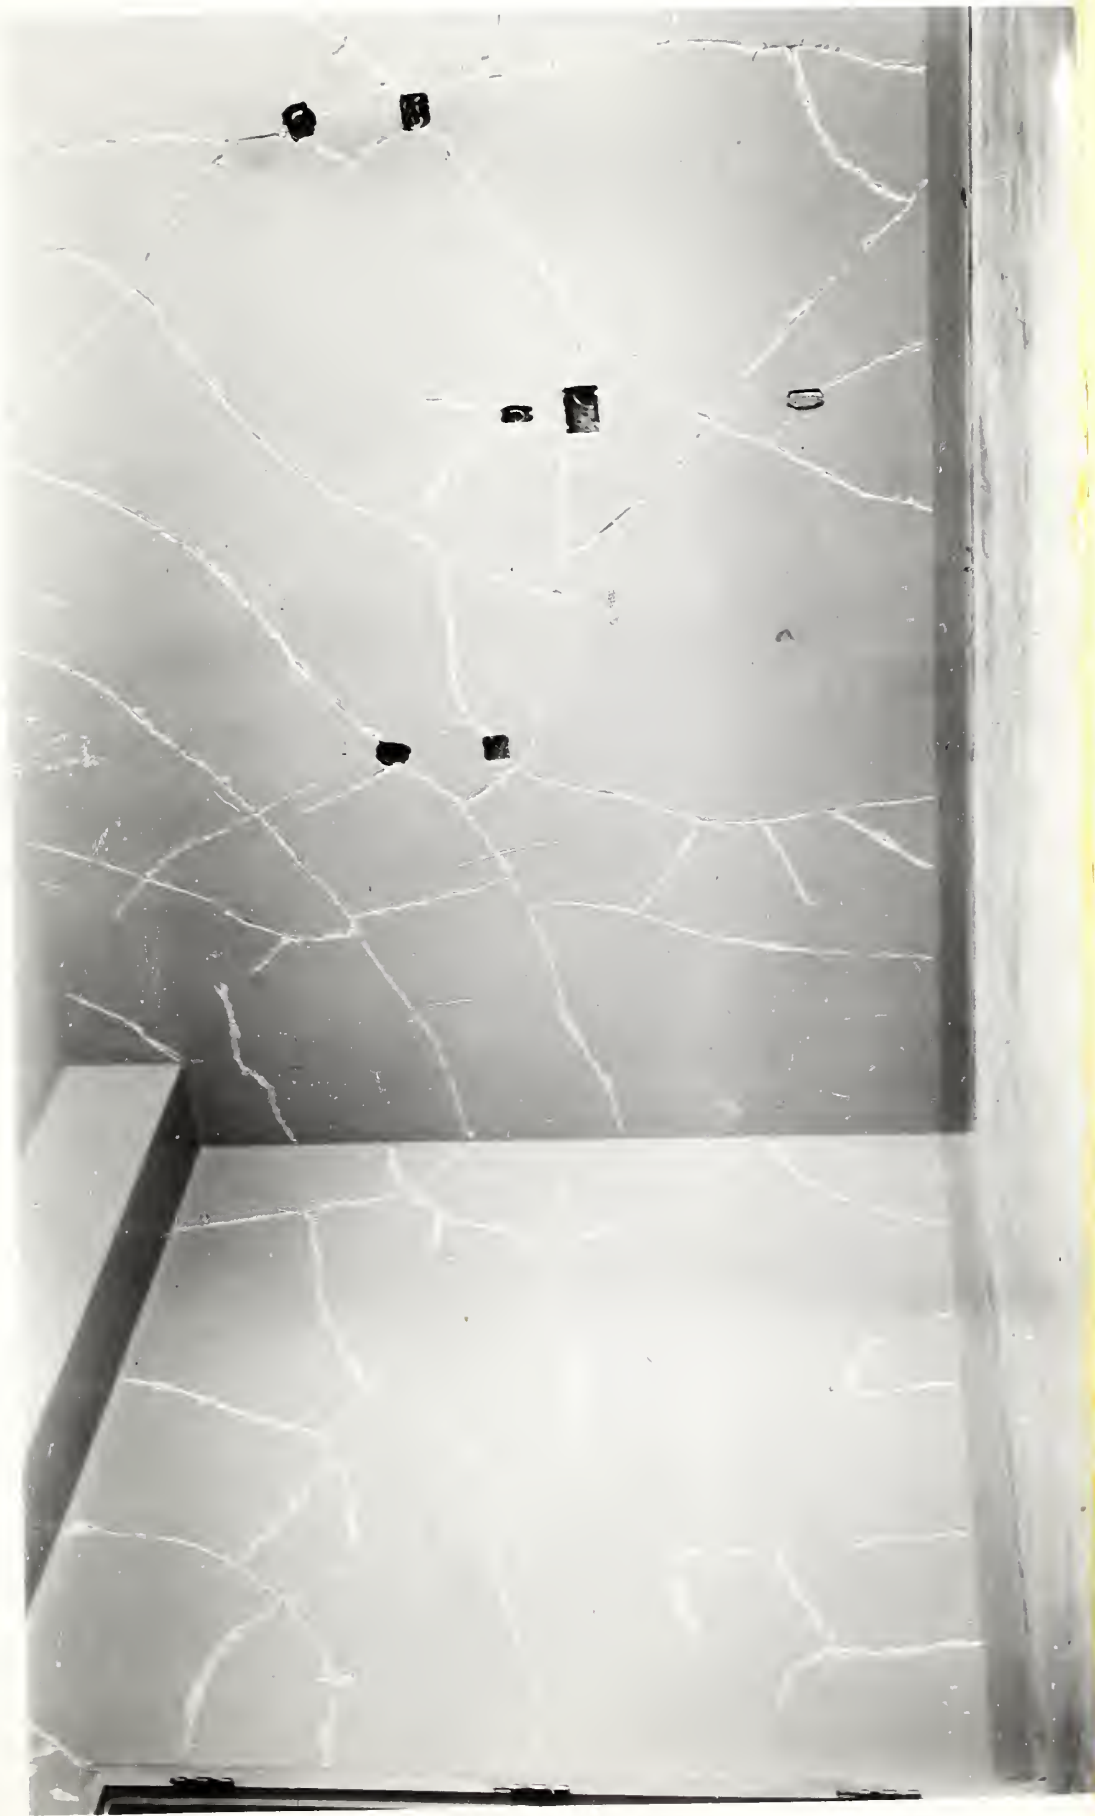
FIGURE 6. PROJECT 501-228. SOUTH AND CORRIDOR WALLS OF ROOM N-518 (PRINTED REVERSED) SHOWING CRACKS GROOVED READY TO BE FILLED.

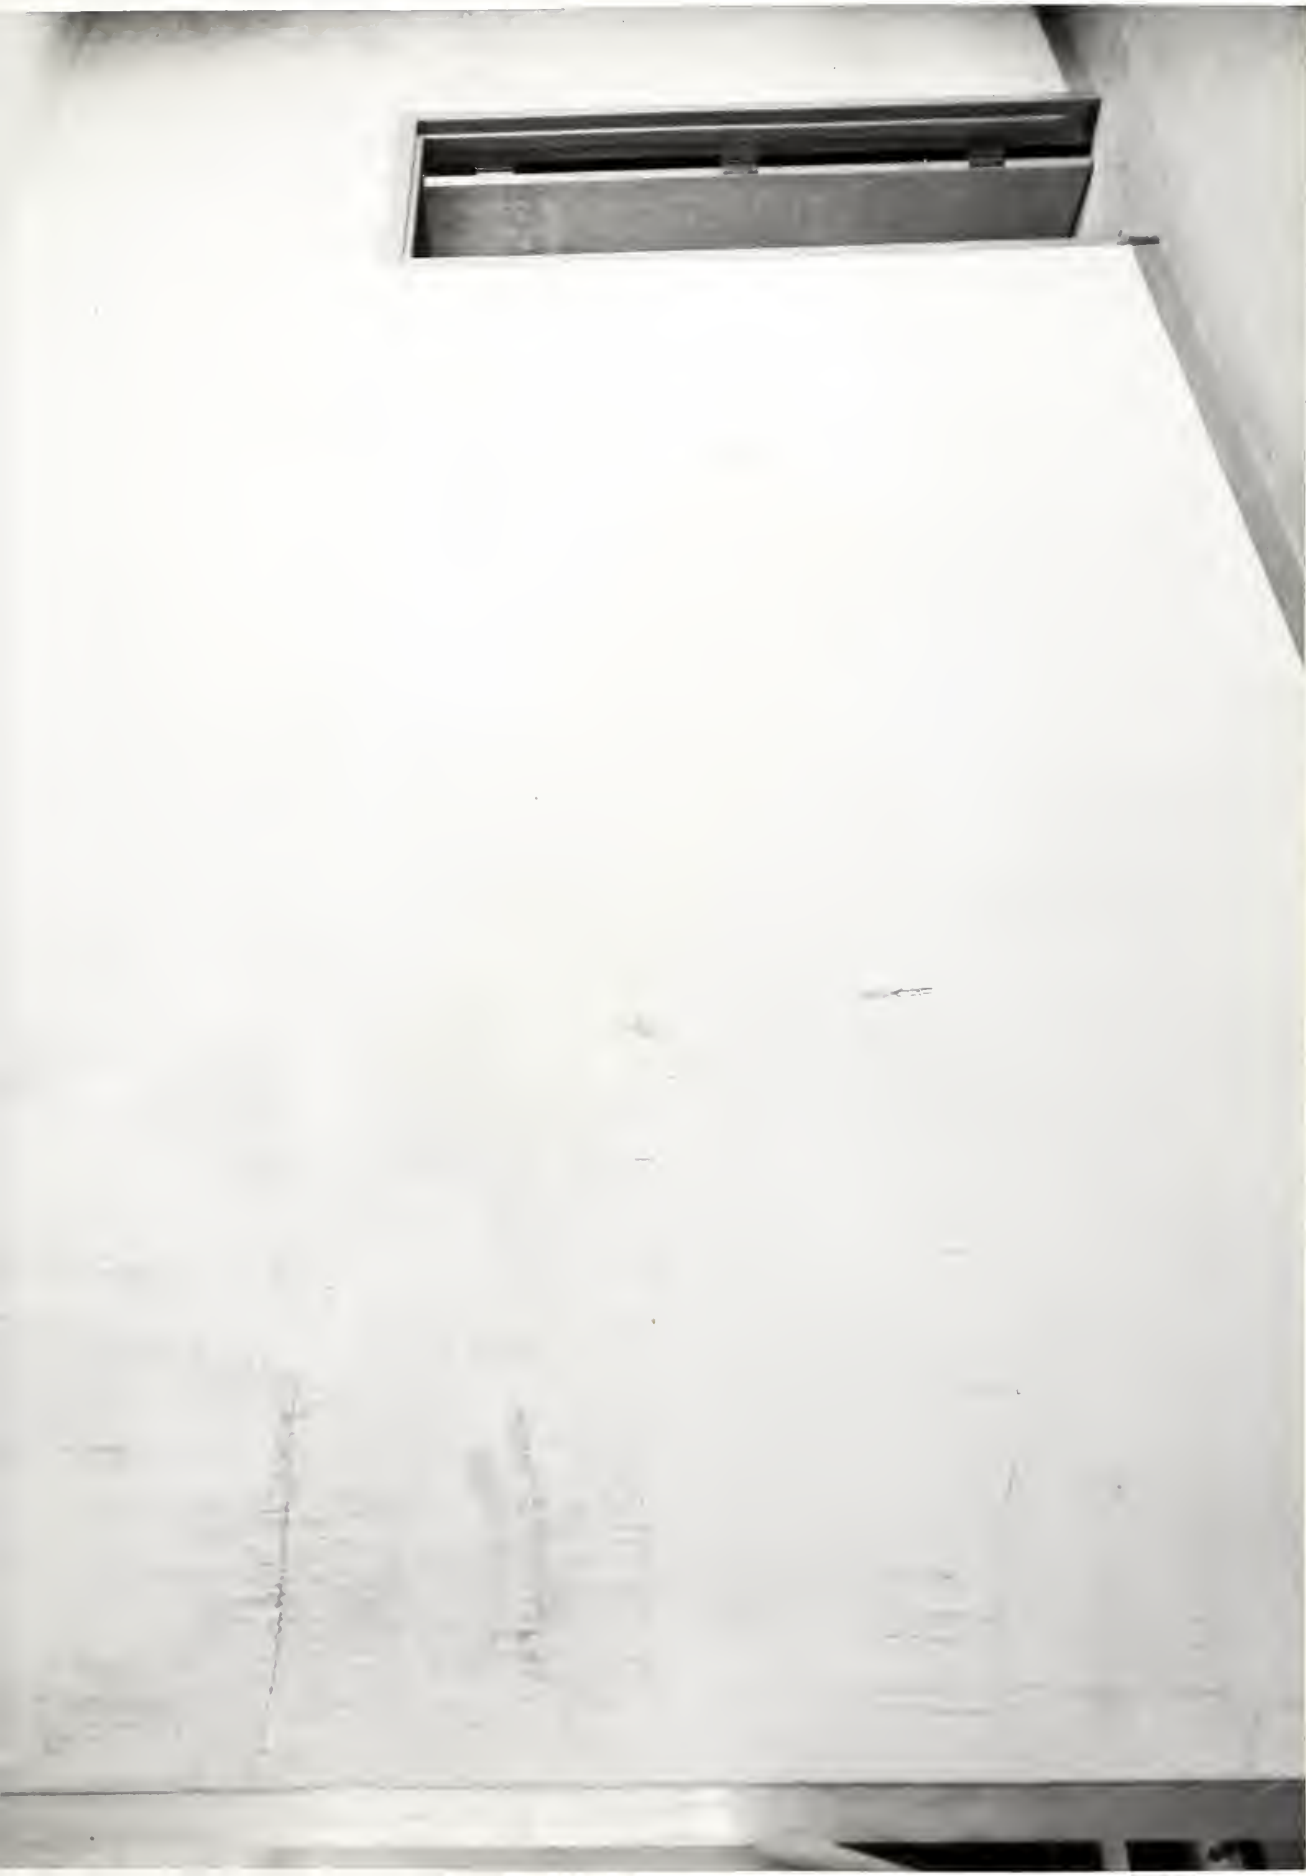
FIGURE 8. PROJECT 501-228. S-100, (SOUTH CORRIDOR) NEAR LAUNDRY ENTRANCE SHOWING CONDITION OF PLASTER ON OCTOBER 22, 1952.

ANCHORAGE HOSPITAL - PROJECT 501-2228
S-100 near laundry entrance
taken October 22, 1952

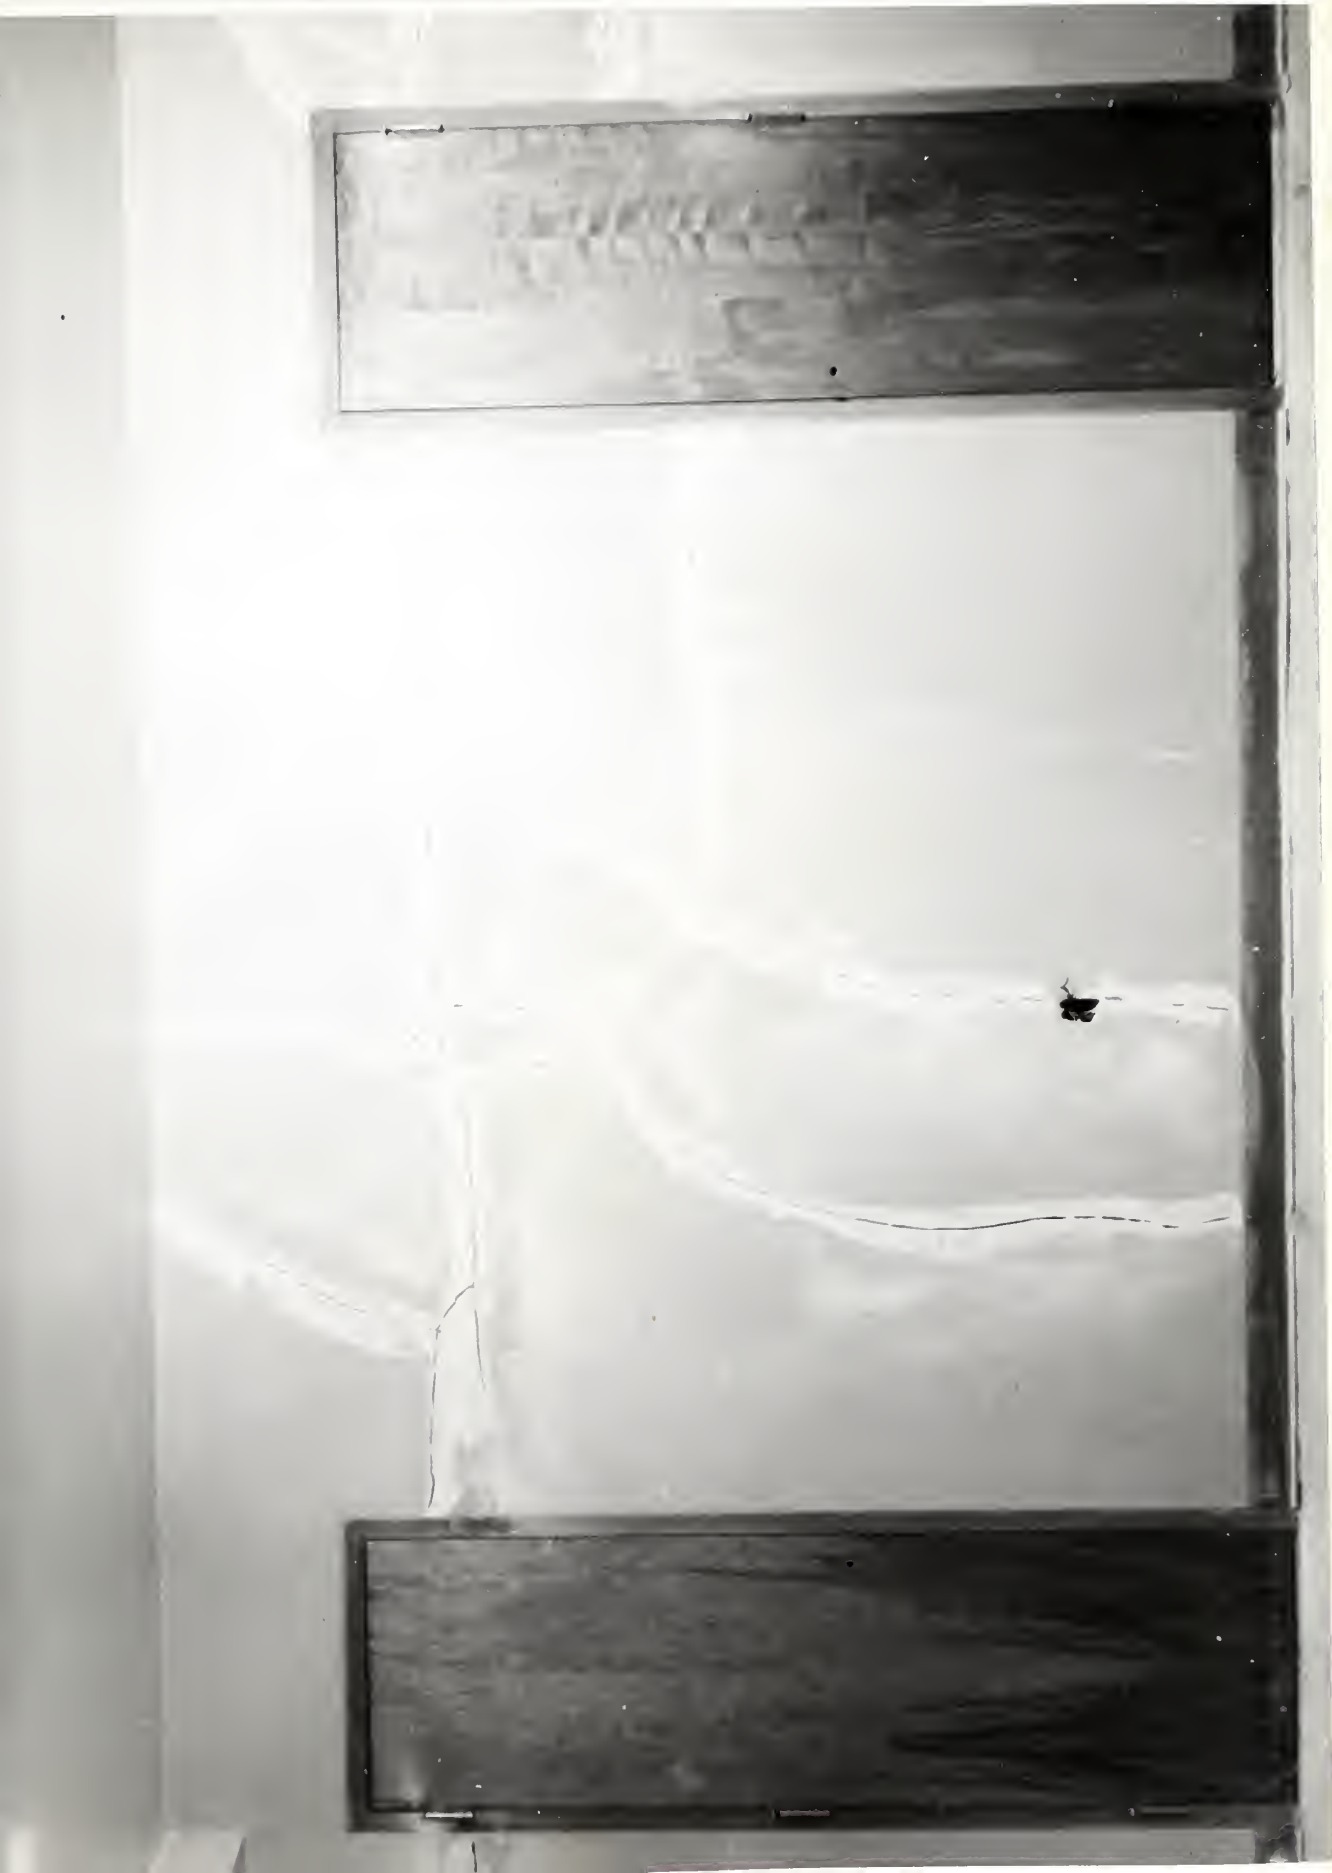
FIGURE 9. PROJECT 501-228A. PATTERN OF CRACKING, NORTH WALL OF ROOM E-240, QUARTERS BUILDING ON NOVEMBER 17, 1952.

ANCHORAGE QUARTERS - PROJECT 501-2284
Room E-240, north wall,
taken November 17, 1952

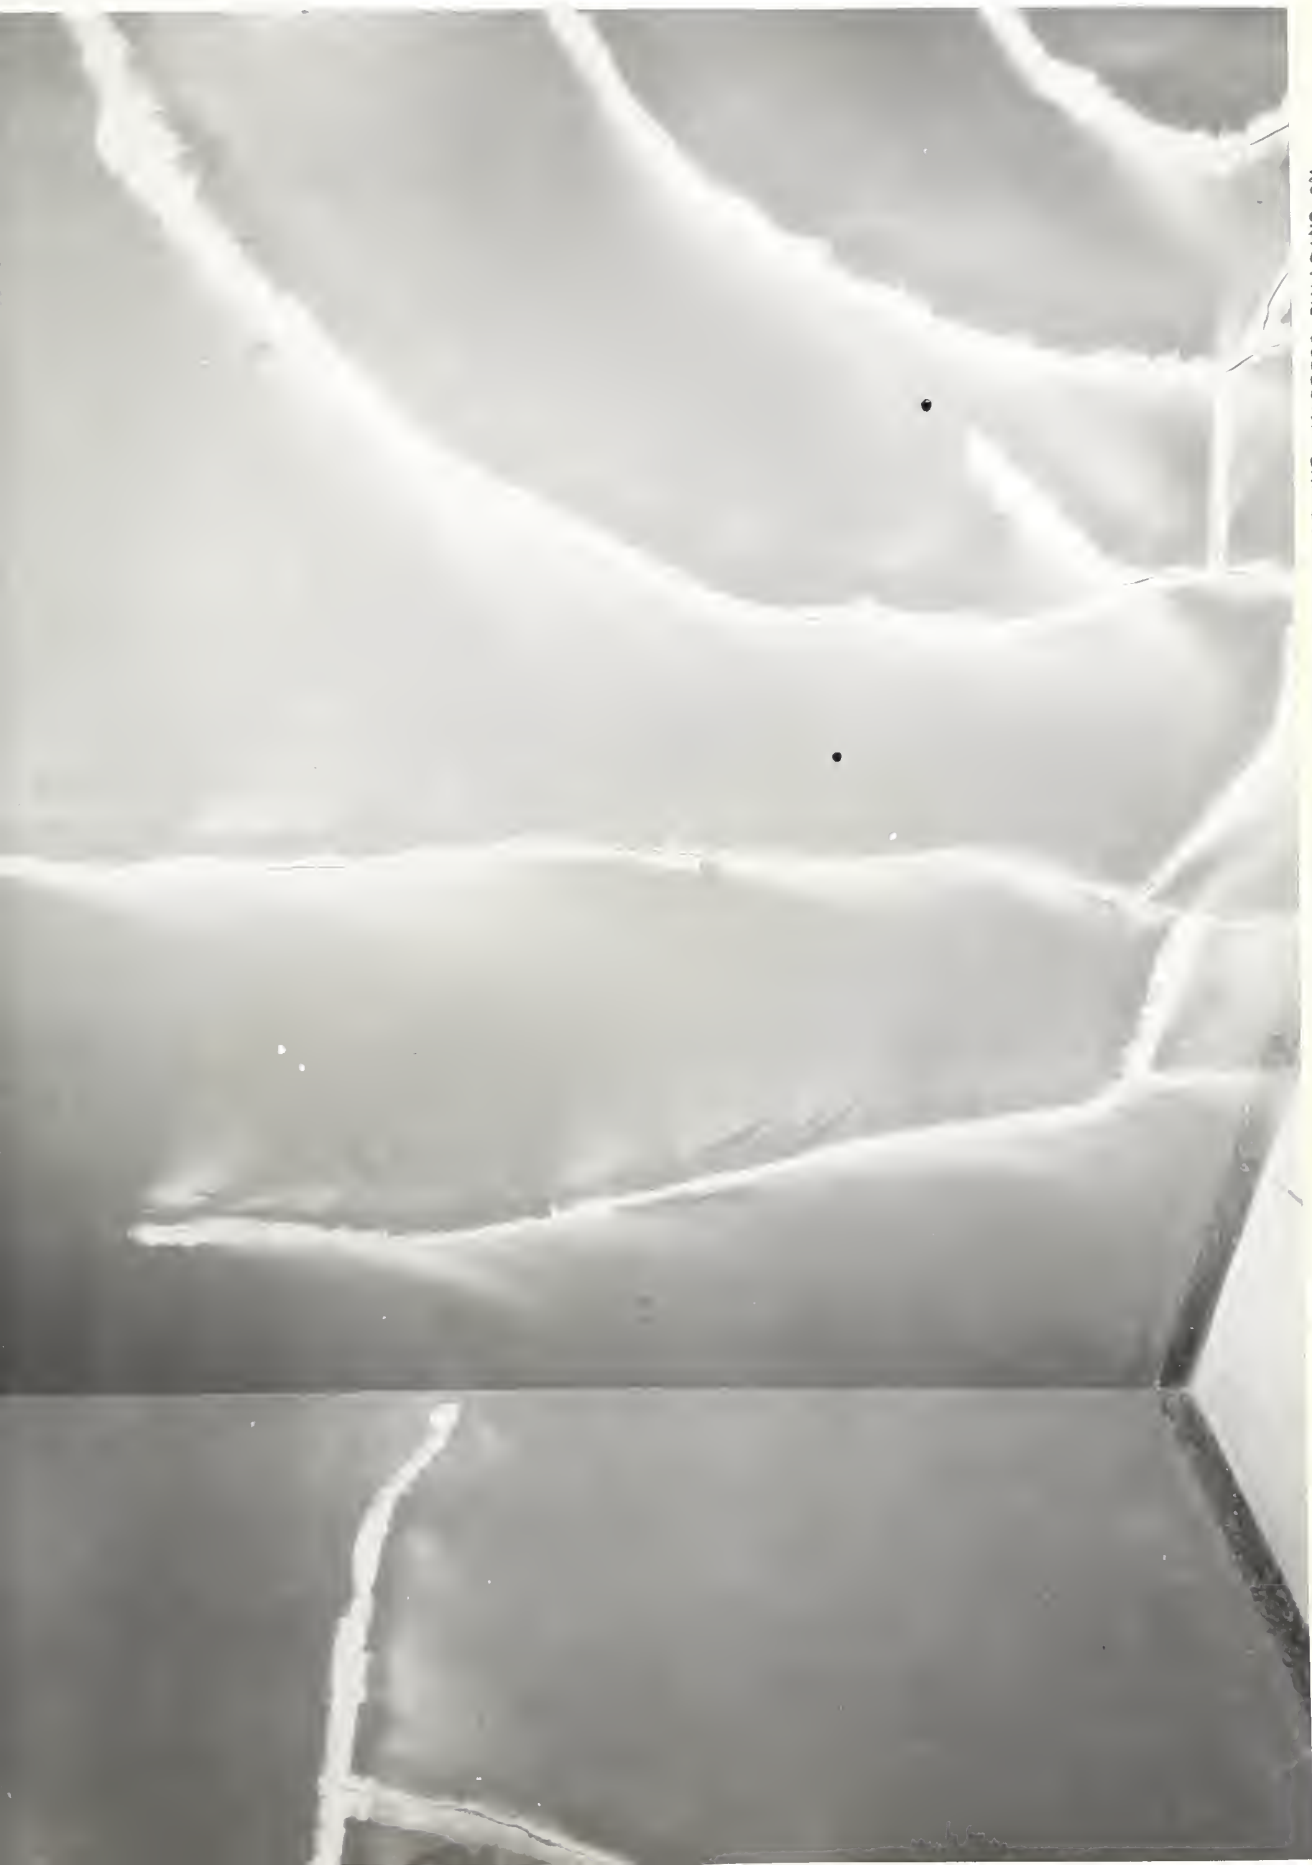
FIGURE 10. PROJECT 501-228A. PATTERN OF CRACKING OF PLASTER OF WALL, ENTRANCE ROOM OF THE QUARTERS BUILDING ON NOVEMBER 19, 1952. THE WARPED PLASTER AT MARGINS OF THE CRACKS HAD BEEN SANDED OFF IN PREPARATION FOR REPAIR. NOTE CLOSER SPACING OF THE CRACKS AT THE BOTTOM OF THE WALL.

· ANCHORAGE QUARTERS - PROJECT 501-228A
Room of entrance of quarters building
taken November 17, 1952
